**DEPARTMENT OF TRANSPORTATION**

Contract #: 04-0120F4Cty: SF/ALA Rte: 80 PM: 13.2/13.9File #: 99.28**WELDING INSPECTION REPORT****Resident Engineer:**Siegenthaler, Peter**Address:** 333 Burma Road**City:** Oakland, CA 94607**Report No:** WIR-024828**Date Inspected:** 02-Jul-2011**Project Name:** SAS Superstructure**OSM Arrival Time:** 700**Prime Contractor:** American Bridge/Fluor Enterprises, a JV**OSM Departure Time:** 1900**Contractor:** Zhenhua Port Machinery Company, Ltd (ZPMC) Chanxing Island**Location:** Shanghai, China

Visual Inspection after Blast

OBG Segment 14W

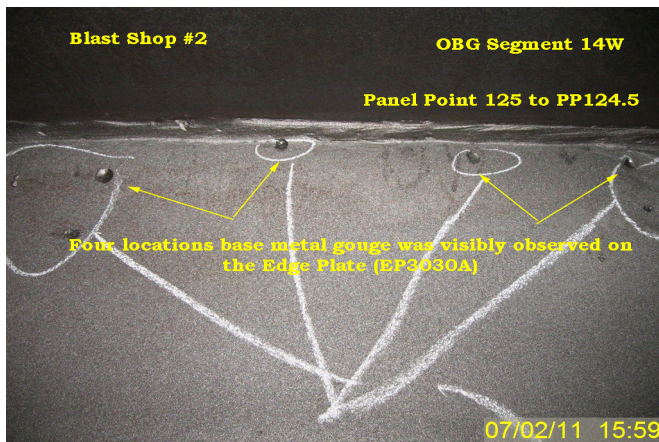
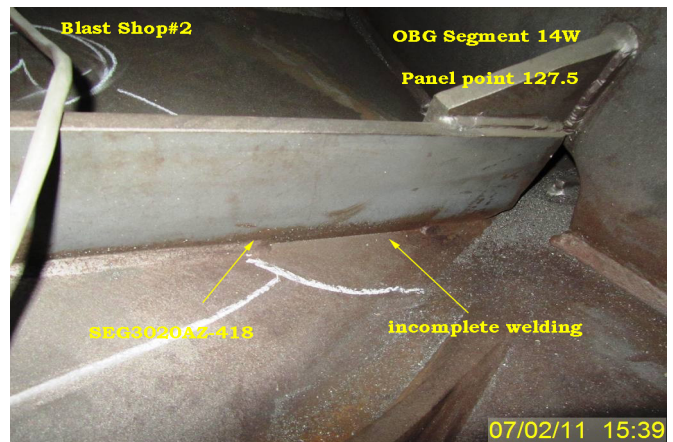
- At PP126 (W) cross beam side, a incomplete welding on the Floor Beam (FB3321A) to side plate (SP3141C).
- In between PP125 and PP125.5 cross beam side, a base metal gouge was visibly observed on the Side Plate (SP3141B).
- At PP125.5 (E) cross beam side, a dent on the Side Plate (SP3140B)
- In between PP125 and PP124.5 cross beam side, a base metal gouge was visibly observed on the Bottom Plate (BP3094A).
- At PP125.5 (E) cross beam side, a base metal gouge was visibly observed on the Side Plate (SP3140A).
- In between PP125 and PP124.5 cross beam side, four locations base metal gouge was visibly observed on the Edge Plate (EP3030A).
- For further information, please see the attached picture.
